[Docket No. 2003-CE-43-AD; Amendment 39-13328; AD 2003-20-10]

Airworthiness Directives; Raytheon Aircraft Company Beech Models 1900, 1900C, and 1900D Airplanes

2003-20-10 Raytheon Aircraft Company: Amendment 39-13328; Docket No. 2003-CE-43-AD.

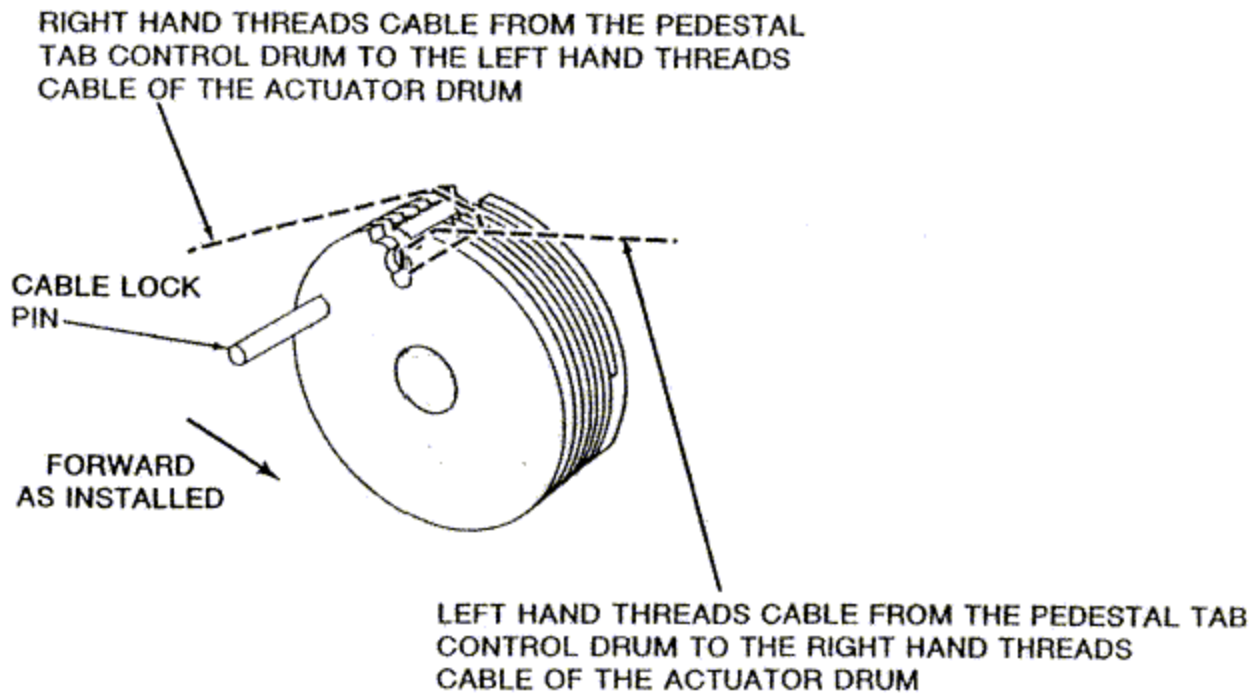
Figure 1

- The figures in the applicable maintenance manuals depict the elevator trim cable drum at 180 degrees from the installed position and show the open, keyed side of the drum instead of the flat side of the drum. Following these figures when installing the control cables on the forward control cable drum could reverse the action of the elevator manual trim system; and
- The existing procedure can be enhanced by visually confirming the trim wheel position and the trim tab position are consistent. Such a check would detect and correct any problems with the elevator trim system installation before problems occur during operation.

Actions	Compliance	Procedures
<p>(1) Using pen and ink, mark the applicable figure in the maintenance manual as referenced below. The depiction in the referenced figures is incorrect for the elevator trim drum only and depicts the cable drum at 180 degrees from the installed position and shows the open, keyed side of the drum instead of the flat side of the drum. Insert corrected figure (Figure 1 of this AD) into the applicable maintenance manual and identify it accordingly:</p> <p>(i) Figure 9 of Chapter 27–10–00 of the Model 1900/1900C Airliner Maintenance Manual (114–590021–7B) Clearly note in pen that existing portion of Figure 9 is correct for the aileron trim drum only and insert corrected figure (Figure 1 of this AD) marked in pen as correct for the elevator trim drum only; or</p> <p>(ii) Mark out Figure 201 of Chapter 27–30–04 of the Model 1900D Airliner Maintenance Manual (125–590000–15). Insert corrected figure (Figure 1 of this AD)</p>	<p>Before the next time you have maintenance done on the elevator trim system.</p>	<p>As specified in Raytheon Safety Communiqué No. 234, dated September 2003.</p>

<p>(2) Incorporate the applicable temporary revision into the maintenance manuals as follows:</p> <p>(i) Temporary Revision No. 27–5 to the Model 1900/1900C Airliner Maintenance Manual: Revised ELEVATOR TRIM OPERATIONAL CHECK; or</p> <p>(ii) Temporary Revision No. 27–9 to the Model 1900D Airliner Maintenance Manual: Added MANUAL ELEVATOR TRIM OPERATIONAL CHECK.</p>	<p>Before the next time you have maintenance done on the elevator trim system.</p>	<p>As specified in Raytheon Safety Communiqué No. 234, dated September 2003.</p>
<p>(3) Do the elevator trim operational check that is specified in the applicable maintenance manual and temporary revisions to the maintenance manual as referenced in paragraph (e)(2) of this AD</p>	<p>Prior to further flight after each time you have maintenance done on the elevator trim system.</p>	<p>As specified in Raytheon Safety Communiqué No. 234, dated September 2003; and Temporary Revision No. 27–5 to the Model 1900/1900C Airliner Maintenance Manual: Revised ELEVATOR TRIM OPERATIONAL CHECK; or Temporary Revision No. 27–9 to the Model 1900D Airliner Maintenance Manual: Added MANUAL ELEVATOR TRIM OPERATIONAL CHECK, both dated September 12, 2003, as applicable.</p>
